Manhole Inspection Summary

Manhole # S23KK_001MH

Insp Date: **7/5/05 9:29 PM**

Location Address: **2479 WOODBROOK AVE**

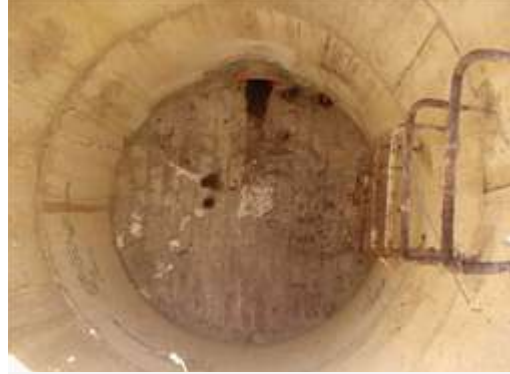
Top View

☒ **Debris** (not Condition related)

☒ **Corroded**

Corroded steps. Channel debris.

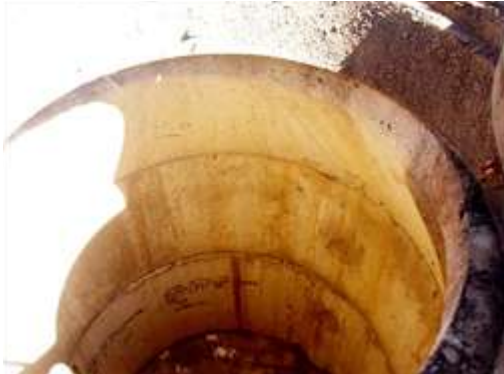
Defect

Offset: **3** (in.)

☒ **Leaks**

Infiltration: ☐ None ☒ **Joint** ☐ Cracks ☐ Mortar ☐ Roots ☐ Wall

Frame leaks. Frame offset. Adjustment and Barrel infiltration - other side.

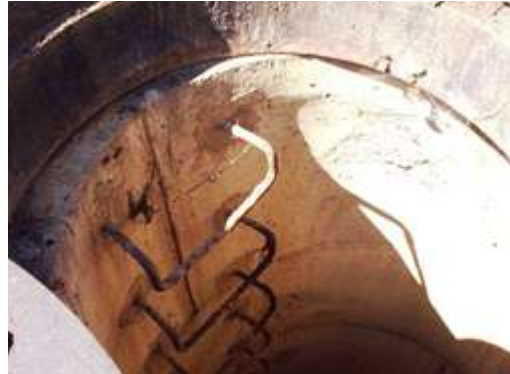
Defect

Frame leaks. Frame offset. Adjustment and Barrel infiltration.

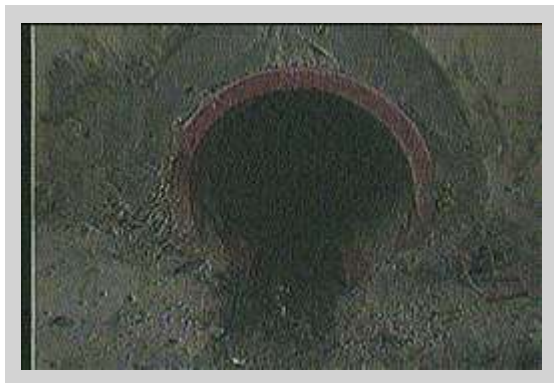
Pipe Out @ 12 O'Clock

Deposits: ☐ None ☒ **Mud** ☐ Sludge ☒ **Debris** ☐ Grease

Silt Depth: **0.5** (in.)

Deposits Extent: **Light**
